DOE/NASA CONTRACTOR REPORT

DOE/NASA CR-150712

DEVELOPMENT AND FABRICATION OF A CONCENTRATING SOLAR COLLECTOR SUBSYSTEM (Second Quarterly Report)

16. ABSTRACT This report covers the progress of work from January 1, 1977, through March 31, 1977, including work on the evacuated receiver, lens design, lens die fabrication, and improvements on components, production techniques, and performance testing. Cost information has been removed.

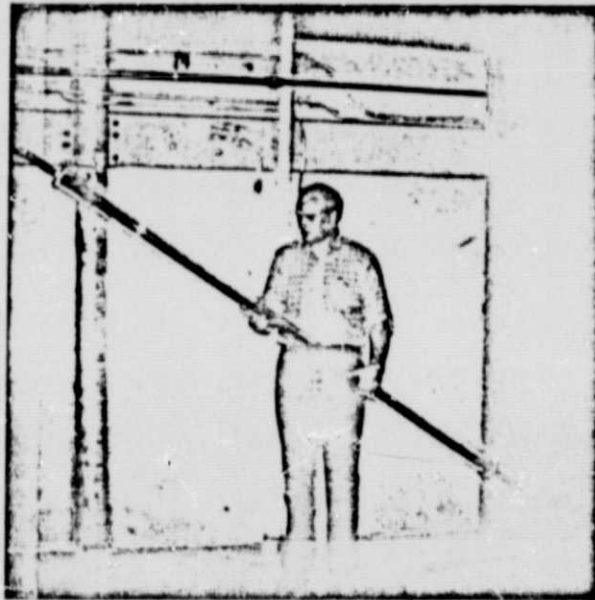
Shown below is a photograph of an evacuated receiver in the Northrup model shop.

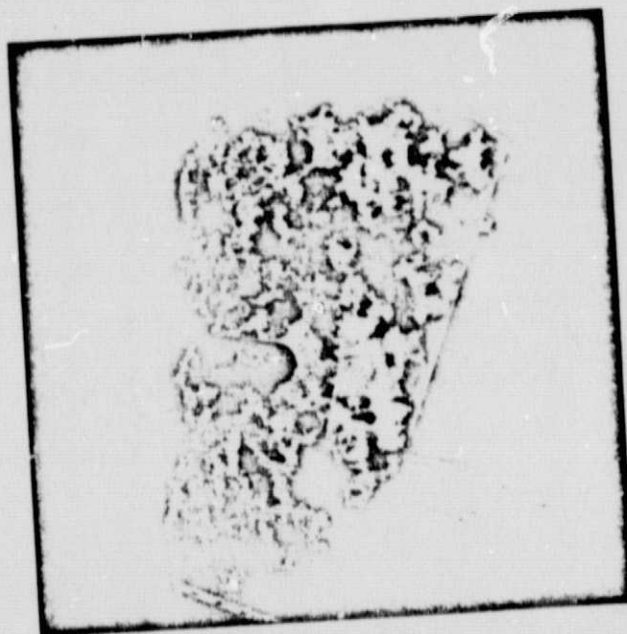
Considerable testing of casing components have been performed to check weatherability. Figure 4 illustrates a salt-spray simulation test, conducted under controlled conditions over a period of several weeks.

Salt Spray tests conducted to determine rust
problems on end panels.

Resistance to corrosion has been improved on the end plates and pivot shafts of the atmospheric receiver housing. This improvement was determined to be necessary when equipment exposed to heavy maritime environment oxidized in limited areas.

Tests consisting of exposing the test parts to salt (Na Cl) and water (H₂O) were run. The tests provided data regarding the resistance to corrosion of several combinations of platings and coatings.

The result of the investigation and testing resulted in three improvements. First, a weld head was added to the pivot shaft to eliminate a cavity where water and other contaminants were collecting and producing corrosion. Second, the Cadmium plating thickness on the pivot shaft weldment was increased from .0002 inch to .0005 inch. Third, a coating of a corrosion resistant paint; "Cold-Galv" which is very high in zinc dust content and conforms to specifications MIL-P-26915A and MIL-T-26433 was selected and applied.
